D05 - 0003

Surface treatments counteracting galvanic corrosion  
from steel screws – outdoor exposure

Marja Melander

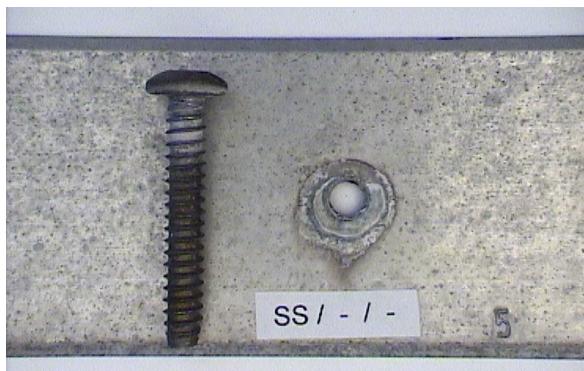
The appearance of the surfaces of the extrusions and screws before cleaning after 10 years exposure are shown in Figures 2a-h. The not anodised profiles had small corrosion pits evenly distributed over the surface. The corrosion was more severe under the screw head than elsewhere. This is the case irrespective of the surface treatment. The cause is galvanic corrosion. After 10 years no rust was seen on the stainless steel screws. Referring to [1], the carbon steel screws started to show red rust after two years of exposure and there was no difference in this respect between carbon steel screws with different surface treatments. After three years galvanic corrosion was visible close to the screws for the not anodised material (regardless of screw material).

a) Stainless steel screw / no surface treated extrusion

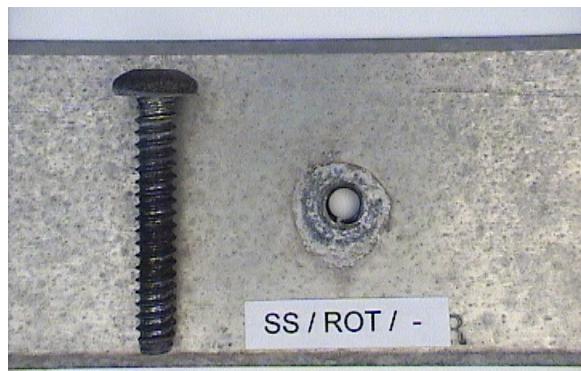
b) Stainless steel screw / Rotalyt / no surface treated extrusion

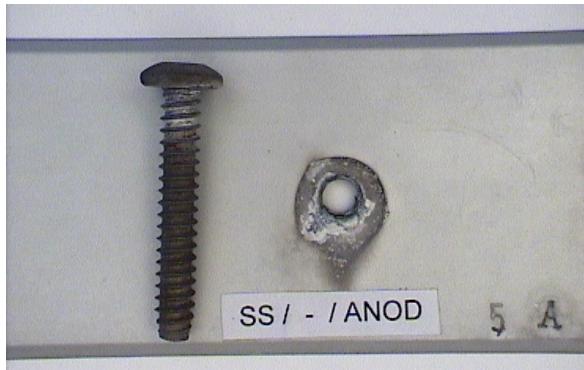
c) Stainless steel screw / anodised extrusion

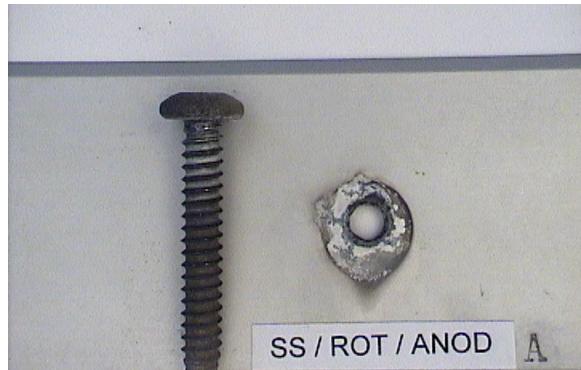
d) Stainless steel screw / Rotalyt / anodised extrusion

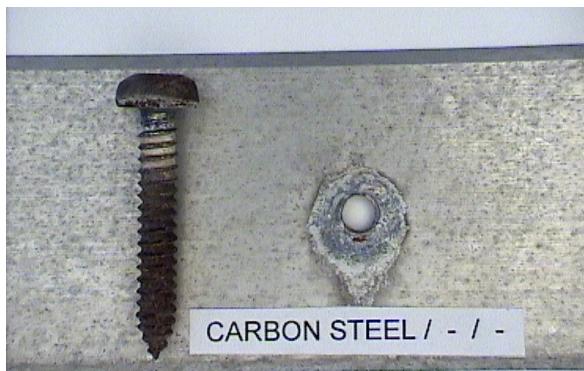
e) Carbon steel screw / no surface treated extrusion

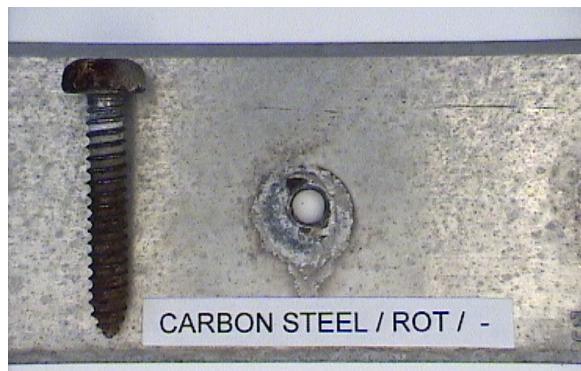
f) Carbon steel screw / Rotalyt / no surface treated extrusion

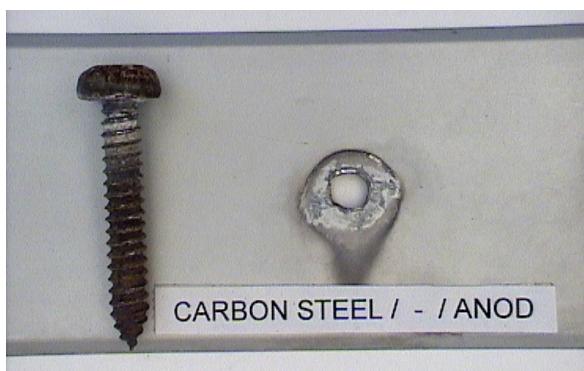
g) Carbon steel screw / anodised extrusion

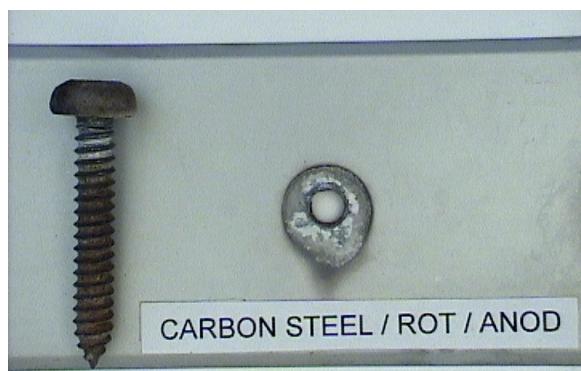
h) Carbon steel screw / Rotalyt / anodised extrusion

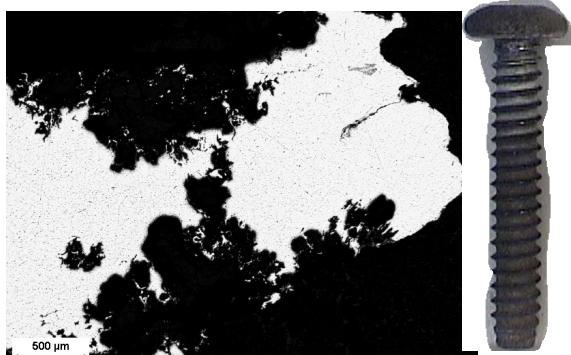
Sections of the extrusions were made for studies in light optical microscope, as shown in Figures 3a-h. The corrosion attacks seem to be severe and more widely spread on the not surface treated extrusions than on the anodised extrusions.

a) Stainless steel screw / no surface treated extrusion

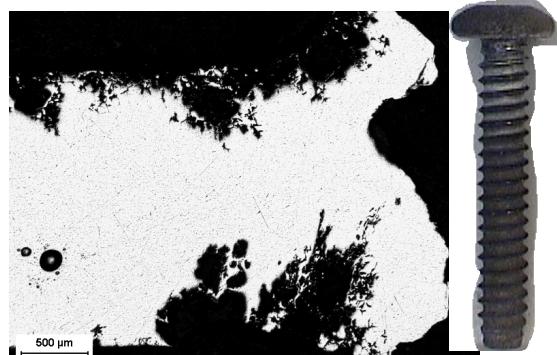
b) Stainless steel screw / Rotalyt / no surface treated extrusion

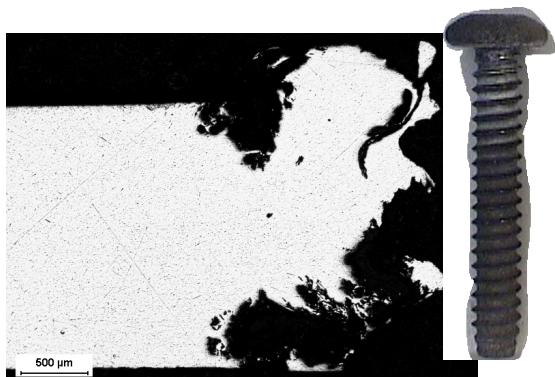
c) Stainless steel screw / anodised extrusion

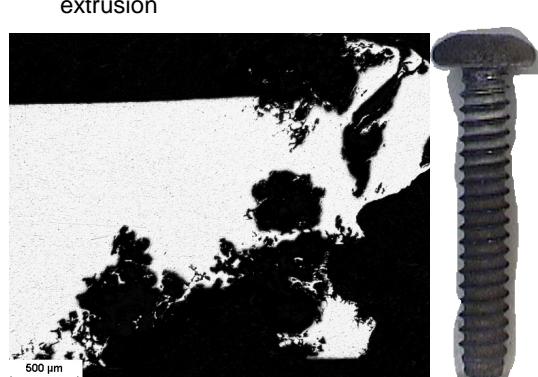
d) Stainless steel screw / Rotalyt / anodised extrusion

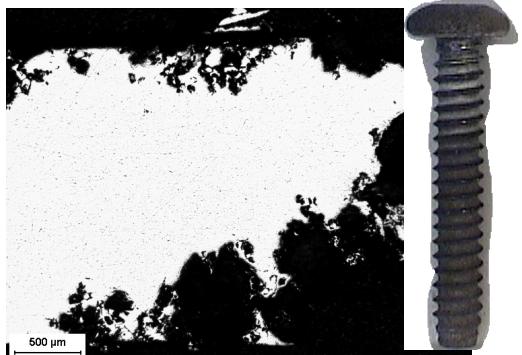
e) Carbon steel screw / no surface treated extrusion

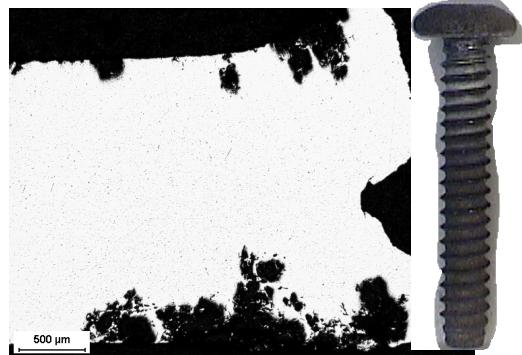
f) Carbon steel screw / Rotalyt / no surface treated extrusion

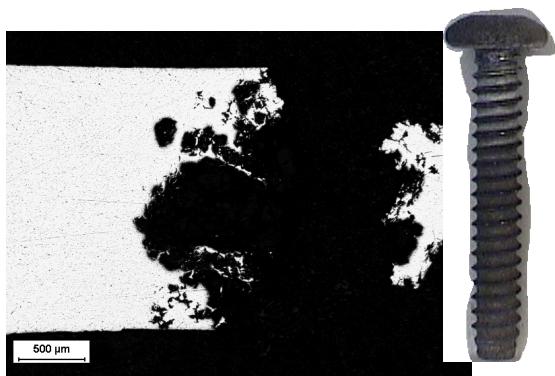
g) Carbon steel screw / anodised extrusion

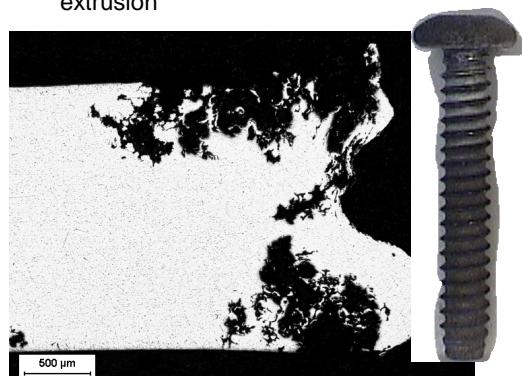
h) Carbon steel screw / Rotalyt / anodised extrusion
