D05 - 0003

Surface treatments counteracting galvanic corrosion  
from steel screws – outdoor exposure

Marja Melander

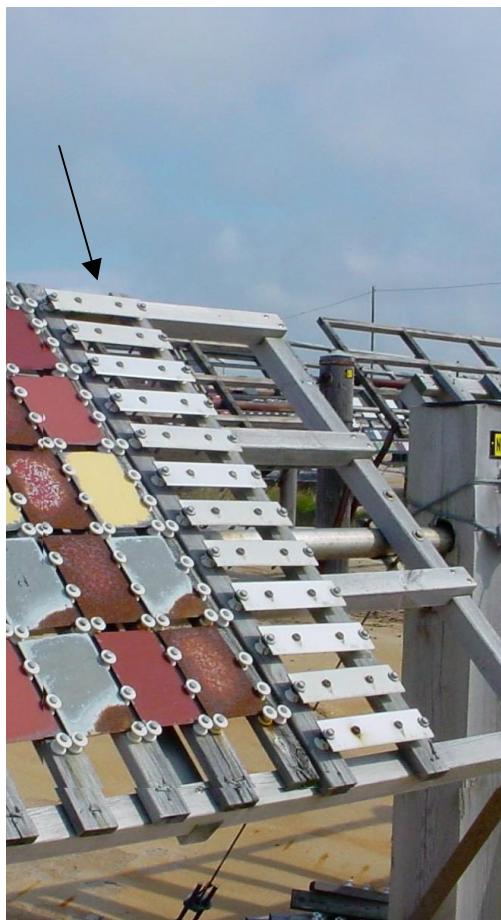
**Figure 1**

The outdoor exposures were performed at the test station Kvarnvik (Bohus Malmön) on the west coast of Sweden. The test station is located a few metres from the coast line, and during hard weather water droplets from the sea hit the samples. All samples were positioned with the surface 45° from the horizontal plane, in a direction towards south, as shown in Figure 1.

A photo of the samples during exposure at the test station Kvarnvik (Bohus Malmön).
